THIRD ENDORSEMENT on NAF, China Lake, AAR #3-58, concerning
F4D-1, BuNo 134762, pilot (b) (6)

SECOND ENDORSEMENT on NAP, China Lake AAR 3-58, concerning F4D-1 BuNo
134762, Pilot LCDR (b) (6) USN

FIRST ENDORSEMENT on NAF- China Lake AAR 3-58, concerning F4D-1 BuNo 134762,
Pilot LCDR (b) (6) USN

AIRCRAFT ACCIDENT REPORT

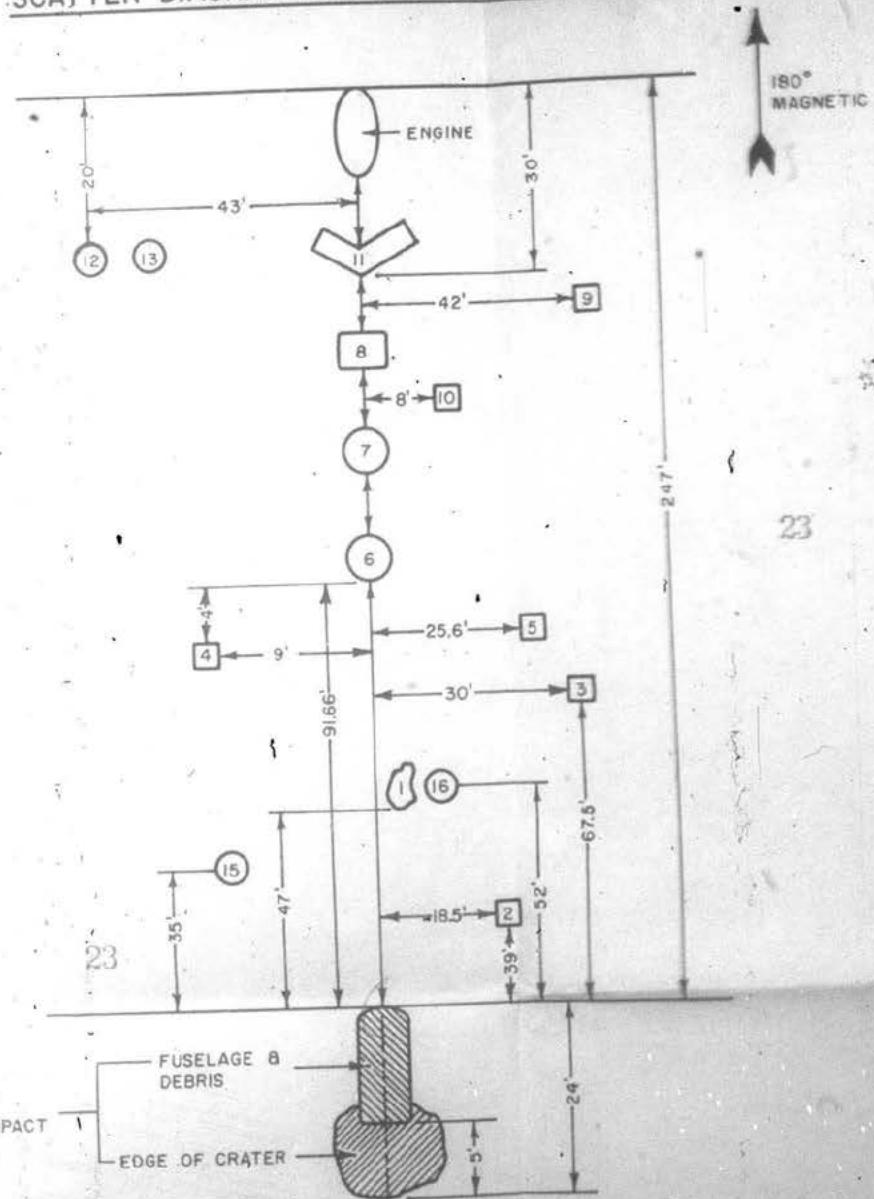
SCATTER DIAGRAM FOR F4D-I BUNO 134762

The point of impact is 14½ miles NNW of NAF China Lake, in a gently sloping, rocky desert area roughly 2800 feet MSL. From all indications, the attitude at impact was wings level, flat, and at a slow airspeed, quite possibly near the stalling point. The depth of the crater at point of initial impact is no greater than one foot, and the main portion of the fuselage, including the nose section, cockpit, nose wheel assembly, etc., moved forward only a distance of about 5 feet before coming to a halt. Main components, such as wings, empennage, engine, afterburner, main landing gear, pitch trimmers, etc., were scattered along a narrow path some 271 feet in length, with a maximum breadth of about 100 ft. Enclosure (8) is a sketch of the scene, indicating relative distances of various components from the point of initial impact. The wings came to rest on opposite sides of the line of travel of the wreckage, that is the port wing lay to starboard of the center line, and the starboard wing to port. This is in spite of the fact that as well as can be deduced from all other evidence, the aircraft did not strike the ground in an inverted attitude.

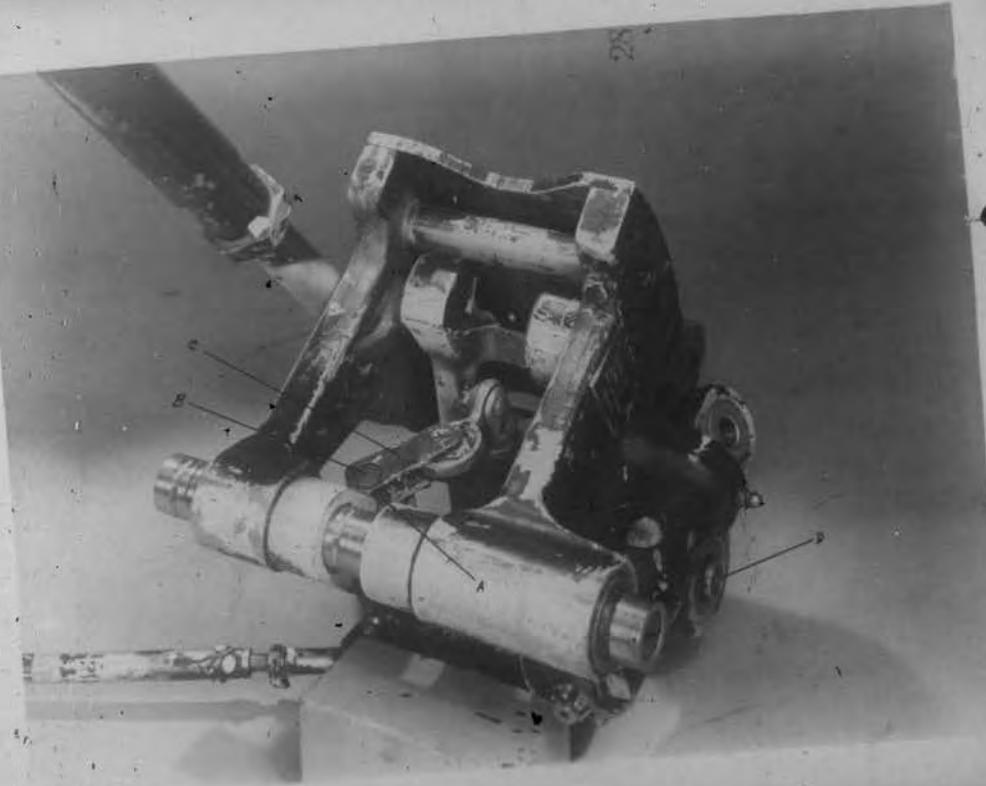
ES 172795 DOUGLAS
FDD-1 1210 5/19/58
ELEVON ACTUATING CRANK ASSY. (SUNO 134762)

c. Disassembly of the starboard actuator crank assembly disclosed that the elevon latch actuating crank pin P/N 5433462-7 (A, enclosure 13), was sheared in two places, allowing relative motion between the elevon latch actuating torque shaft, P/N 2438206, and the lower elevon latch actuating crank P/N 2438205 (B & C, enclosure 13). The corresponding latch pin from the port elevon crank assembly was bent, and appeared to be on the verge of failure. All crank pin holes on both port and starboard assemblies were slightly elongated. Enclosures (14) and (15) are photographs of the starboard and port crank pins, respectively.

The condition of both crank pins and pin holes indicates a gradual deterioration of desired assembly rigidity, probably aggravated by repeated recocking of the disconnect mechanisms by maintenance personnel during routine functional checks, and by resonant vibration in flight.
